DEPARTMENT OF TRANSPORTATION

Contract #: 04-0120F4Cty: SF/ALA Rte: 80 PM: 13.2/13.9File #: 69.28**WELDING INSPECTION REPORT****Resident Engineer:**Pursell, Gary**Address:** 333 Burma Road**City:** Oakland, CA 94607**Report No:** WIR-000099**Date Inspected:** 13-Mar-2007**Project Name:** SAS Superstructure**OSM Arrival Time:** 800**Prime Contractor:** American Bridge/Fluor Enterprises, a JV**OSM Departure Time:** 1430**Contractor:** Zhenhua Port Machinery Company, Ltd (ZPMC), Changxing Island **Location:** Shanghai, China**CWI Name:** Liu Liu and Huang Wei**CWI Present:** Yes No**Inspected CWI report:** Yes No N/A**Rod Oven in Use:** Yes No N/A**Electrode to specification:** Yes No N/A**Weld Procedures Followed:** Yes No N/A**Qualified Welders:** Yes No N/A**Verified Joint Fit-up:** Yes No N/A**Approved Drawings:** Yes No N/A**Approved WPS:** Yes No N/A**Delayed / Cancelled:** Yes No N/A**Bridge No:** 34-0006**Component:** N/A**Summary of Items Observed:**

Welding Qualification HP 200712-2

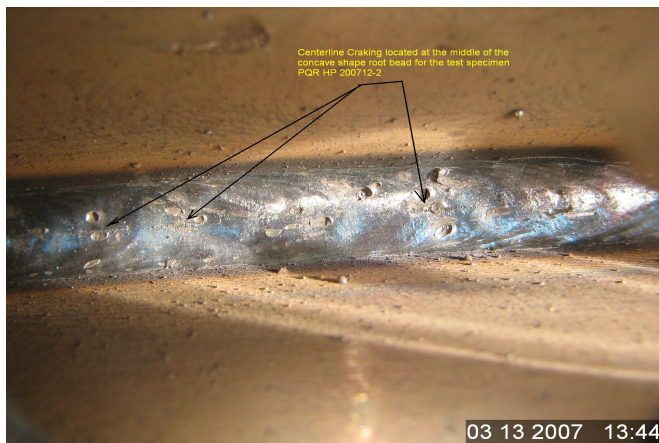
The CALTRANS Quality Assurance (QA) Inspector, Alfredo Acuna was present for the welding qualification testing pertinent for the welding qualification record (PQR) HP200712-2 (second attempt) scheduled for this project. ZPMC, welder operator Jiang Xiao Hu was observed by the QA Inspector performing welding operations following the preliminary welding procedure specification PWPS-B-T-223(2)1T-1 for the PQR identified as HP200712-2. Base metal was designated as A-709-50-2/Z25 (Heat # 06102938N) and appeared to meet the non fracture critical impact test requirement. The root opening of the joint was approximately 6 mm. ZPMC followed AWS 5.13 the production procedure WPS using the automatic flux cored arc welding gas (FCAW-G) process in the flat (1G) position with the 1.4 mm diameter TWE-711 electrode. The QA Inspector verified dimensions for the test coupon, amperages, voltages, travel speed and preheat temperature. The QA inspectors recorded temperature and welding parameters on the root pass and appeared to be in accordance with the Contract documents. ZPMC rejected the test specimen after visual inspection due to the presence of numerous centerline root cracks on the test coupon. The QA inspector concurred with ZPMC.

The digital photograph below depicts a typical linear indication found on the test coupon for the PQR 200712-2 rejected by ZPMC.
